I-70 West Vail Pass Habitat Linkage Structure Location, Design Criteria, and Conceptual Design Report

Colorado Department of Transportation Region 3

Structure Location and Conceptual Design Report Region 3

Prepared by: Felsburg Holt & Ullevig

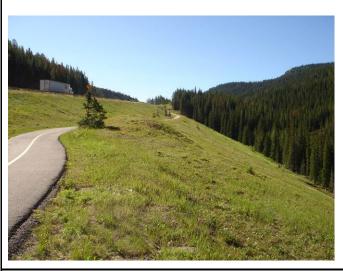
Taken at end of proposed fence line A, looking toward the bridge structure location. This photo is taken from the end of the fencing length A, near the trees in Photo 1.

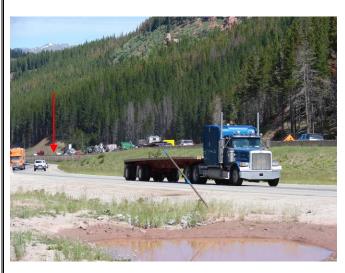
PHOTO 3:

Picture near the structure location looking north across the highway. The retaining wall is visible to the right of the orange semi-truck in the background. Note that the water quality pond is being fenced out and that animals will not be attracted to areas near the highway. It is the intended that a water feature will be designed near the structure to serve as a wildlife attractant.

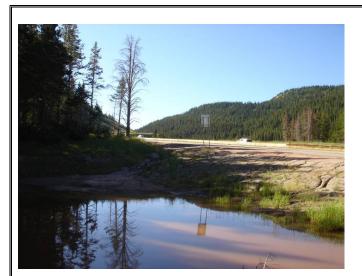
PHOTO 4:

The large SCAP pond northwest of the structure location marked at milepost 187.34. This pond will be fenced to exclude wildlife for maintenance purposes.

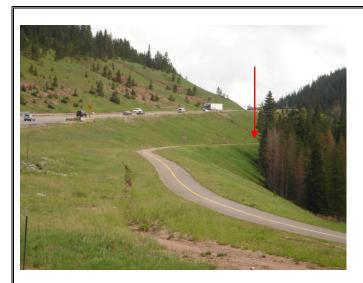
PHOTO 7:

Picture taken near structure location. Note the tree cover on the right and the steep fill-slope on the left of the multi-modal trail. The fence is proposed to end at the eroded culvert/drainage (see arrow).

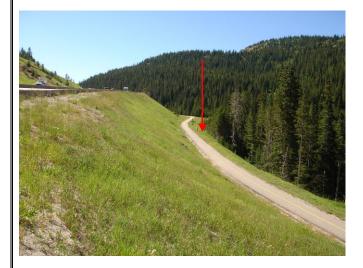
PHOTO 8:

Taken at the end of Fence C extents. Looking east, this picture shows where the fence would end next to tree cover. The arrow depicts the end of the fencing

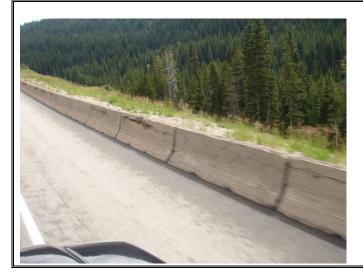
PHOTO 9:

Taken from the highway near the fence end. This photo faces southeast. Guard rail and steep slopes discourages animals from crossing the roadway in these sections.

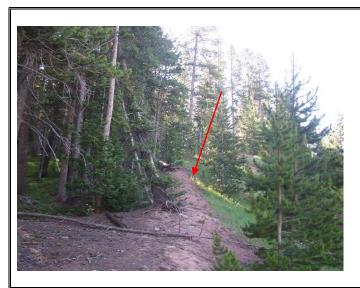
PHOTO 10:

The fence would end mid-photo where the clump of trees are to the left of the center barren ground. The northeast end of the fence would end at the arrow and then move toward the roadway.

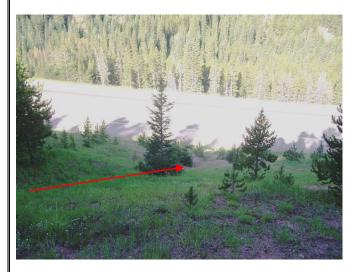
PHOTO 11:

This picture displays a narrow drainage from this slope. There are already several large rocks closer to the highway in the slope. The northeast section of fencing extends down slope to the riprap, yet outside of the I-70 clear zone.

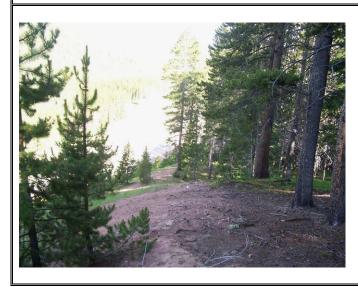
PHOTO 12:

Taken near fence end looking northwest toward the structure location. The fence placement would be between the trees and the cut-slope along the noticeable barren ground. There are wildlife movements parallel to the roadway and the fencing in this location attempts to capture this movement and direct the animals toward the structure.

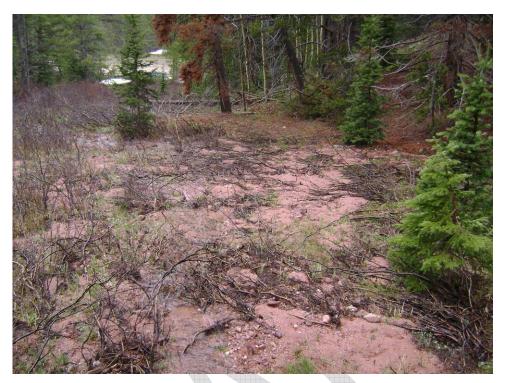
Figure 2 – Debris Flow Channel Looking South towards I-70.

The site is located 2 miles west of the summit of Vail Pass on I-70 at milepost 187. The site is at the base of a moderately sloping drainage formed by Black Gore Creek and is at an approximate elevation of 10,250 feet. Steeply sloping sections and hummocky displaced bedrock are found within the drainage. Currently, there are four lanes of traffic where the wildlife crossing is proposed. Above the crossing site is a steep, narrow gulch that appears to have periodic debris flow events that have the potential to impact the roadway periodically (Figure 2). Water flow on the slope is also in the form of seeps and springs and varies seasonally.

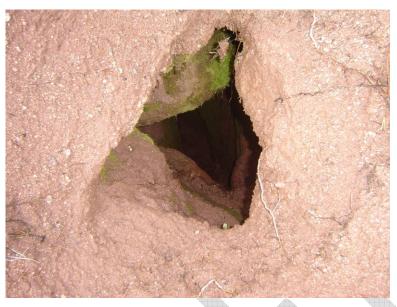
Figure 6. Looking Down Void North of Proposed Site

Based on our cursory field reconnaissance, it appears that the displaced bedrock blocks within the landslide can form block supported voids that create openings in excess of 2 feet in diameter with depths of 10 to 20 feet. Figures 6 and 7 depict a void anomaly that is located approximately 300 feet north of the proposed bridge structure. No voids were encountered in the borings at the proposed abutments and pier locations, however we have noted voids to document that they exist in the area.
